Stress Relaxation Cracking in Austenitic Materials: Mechanism, Mitigation, and ASME BPVC Code Considerations

BAHER ELSHEIKH

ASME Authorized Instructor, CRL, CRE, API 571, API 580 - SABIC- Agri-Nutrients

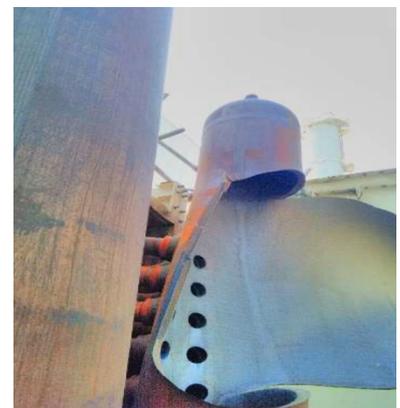
Figure 1 [Ruptured Superheater steam coil, SS316H by SRC [2]]- shows the rupture of a superheated steam coil outlet header, made from 48 mm thick SS316H, caused by stress relaxation cracking (SRC) at the longitudinal seam weld. The rupture resulted in extensive damage within the convection section of the steam reformer at a methanol plant. Additionally, large fragments of debris were projected up to 100 meters across the site, impacting surrounding areas [2]

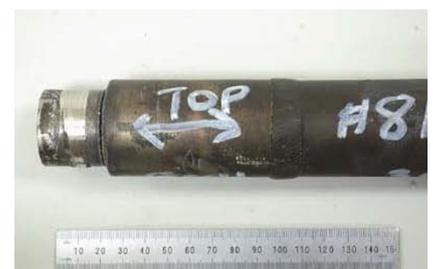
Figure-3, SRC of alloy 800HT inlet pigtail [8]

This API technical report addresses material selection, fabrication, and repair concerns for hydrogen and syngas reformer furnace outlet pigtails and manifolds. It highlights SRC as a major failure mode in these components when exposed to fabrication and operating temperatures between 500°C and 750°C. Additionally, the report includes a case history of SRC occurred in pigtail fabricated from alloy 800HT see Figure-3.

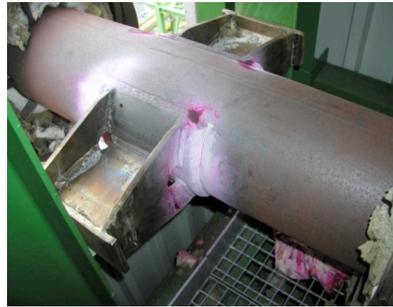
Figure 5-a Cracked pads of horizontal guides [13]

Inlet piping of steam reformer fabricated from SS 347H failed at welded support pad. Cracking occurred in less than 16 months. The failures were observed in welded reinforcing pads and branch connections of inlet pipes. Notably, no Post-Weld Heat Treatment (PWHT) had been applied.
