18th World Conference on Nondestructive Testing, 16-20 April 2012, Durban, South Africa

Ultrasonic Multi-Skip Inspection at Clamped Saddle Supports

Maarten LORENZ¹, Stefan LEWANDOWSKI²

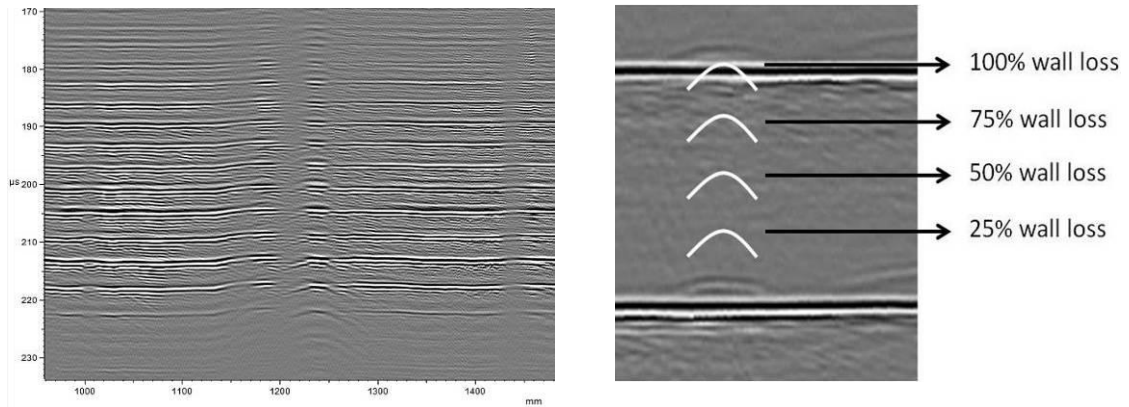
Figure 6. A ToFD representation of Multi-Skip measurements; interaction with local wall loss results in the earlier arrival of the defect signal.

In practice, Multi-Skip measurements are made with scanning ultrasonic Time of Flight Diffraction (ToFD) equipment, providing grey-level plots showing amplitude as function of scan position (x-axis) and time (y-axis), as shown in figure 6.

The general (average) wall thickness can be calculated from the arrival times of a series of skip signals using a least-squares fit algorithm. A local wall loss response will show up as an arc-type signal somewhere between two skip signals (see right picture in figure 6). Although there is a non-linear relation between the travel time of a skip signal and that of a local wall loss response, it is not difficult to calculate the local wall loss based on the difference between the skip and the wall loss signal arrival times. For the slug catcher configuration, the relation between wall loss and travel time difference (with respect to a skip signal) is almost linear.

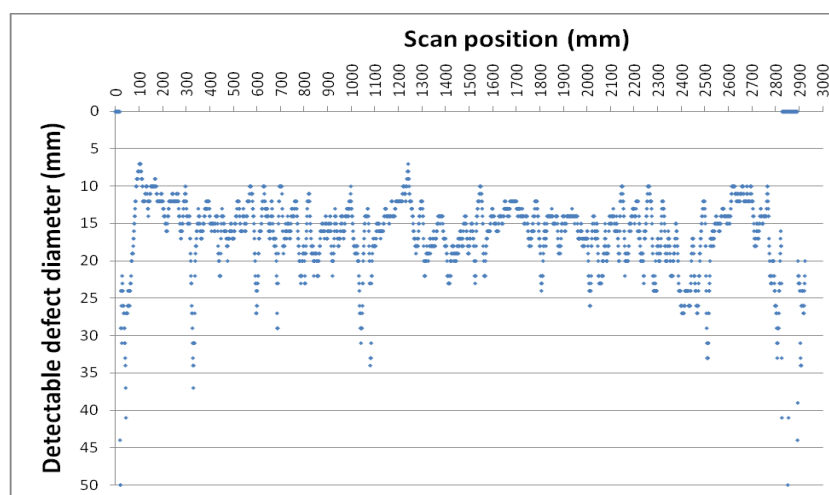
Figure 9. Example of a (field data) sensitivity graph in terms of minimum detectable wall loss area diameter instead of SNR, using a conversion from SNR to defect diameter as calculated by a theoretical model.

In practice, it is fairly difficult to meet >12 dB SNR along the full scan, because of the amplitude reduction due to local surface roughness, the presence of coating layers and probe alignment variations. In order not to miss a 40 mm diameter wall loss defect, the sensitivity level shall not drop below 12 dB for over 40 mm scan length. However, if this requirement is locally not met during an inspection, this would mean that the entire inspection would fail. In order to avoid such problems in practice, it is suggested to look at sensitivity in a more dynamic way. Instead of tracking the SNR as sensitivity level, the diameter values of the corresponding wall loss defects are used as sensitivity level. For instance, instead of discarding the whole scan because of a local drop below the 12 dB threshold, a local sensitivity to 50 mm diameter defects could be regarded tolerable if no wall loss is detected anywhere in the vicinity of that location. A sensitivity graph of a Multi-Skip scan could therefore look like the one shown in figure 9.

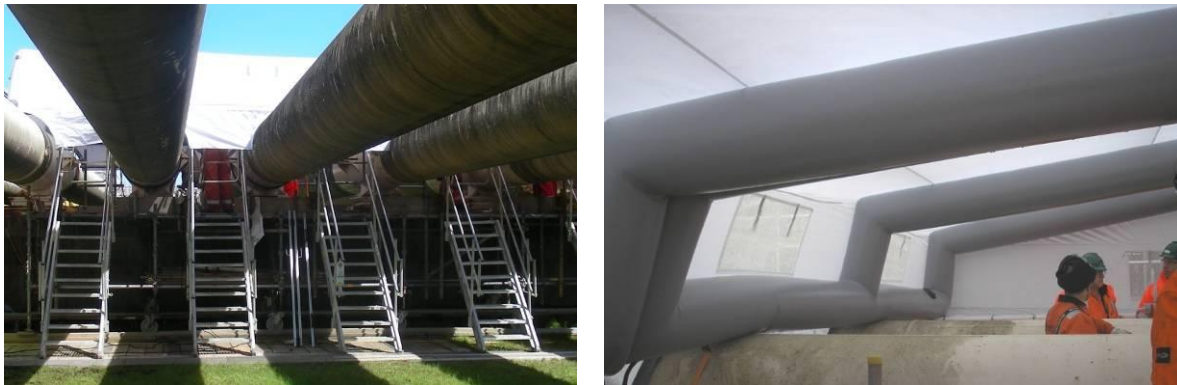
Figure 10. Smart access options: movable scaffolding on rails (after removal of stairs) and inflatable weather protection.

After successful testing of the scanner and probe set-up on a real-size mock-up with artificial wall loss defects, the complete inspection of 143 supports was performed by Sonomatic Ltd in 40 days. Contributing to this achievement were the deployment of smart access solutions, in the form of movable scaffolding (on rails) and inflatable weather protection (see figure 10). All recorded data sets met the required data quality (sensitivity and accuracy) requirements to an acceptable level and no significant wall loss was observed. Minute variations in the general wall thickness (0.1-0.4mm) were detected. Such local variations in wall thickness in the circumferential direction seem to be constant in the axial direction and could be regarded as very shallow “grooves” resulting from the manufacturing process. The corresponding Multi-Skip responses of figure 11 show good agreement with the local zero-degree wall thickness variations as measured at the probe locations on either side of the support.

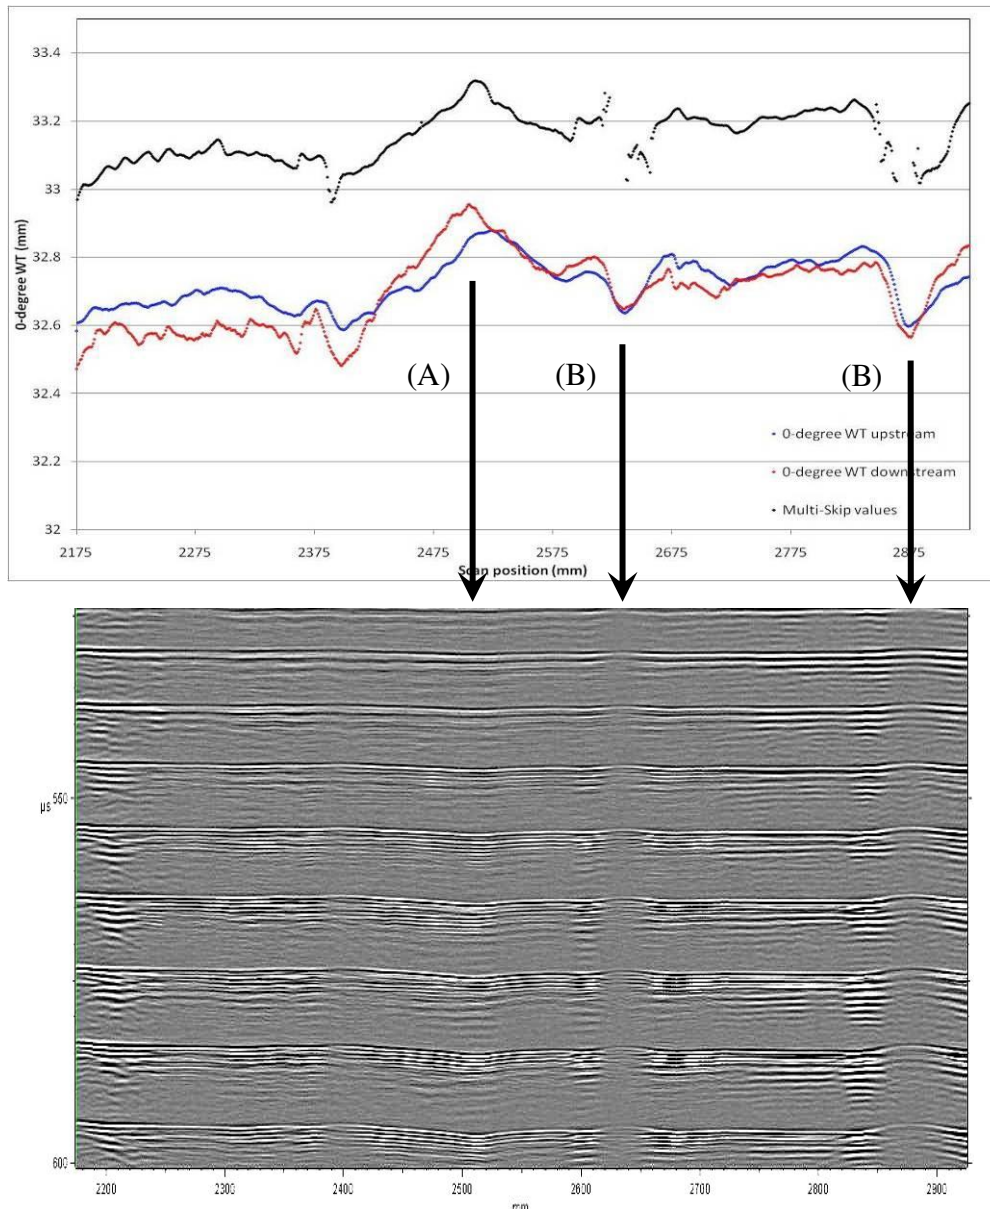
Figure 11. The Multi-Skip responses and the calculated average wall thickness as a result of minute local circumferential variations in wall thickness: dipping skips for a locally thicker (“strip”) part of the pipe at position (A) and gradually bulging skips for locally thinner (“groove”) parts of the pipe at positions (B); the red & blue lines are the 0-degree wall thickness values from both sides of the support; graphs calculated with NTPLOT software from ESR Technology Ltd..

It has been found that the average wall thickness values calculated from Multi-Skip responses are generally a little higher (0.5 - 0.8 mm) than the 0-degree values (see figure 11). The exact reason for this discrepancy has not been determined yet, but is believed to be caused by a combination of possible phenomena: wave velocity variations, anisotropy of steel and/or coupling layer variations.

Because of the bitumen wrap around the full pipe at the support locations, no external wall loss corrosion was expected. The Multi-Skip inspection appeared to be an excellent technique to prove just that, as it is highly sensitive to the effect of relatively small areas of wall loss. It could be shown that the sensitivity of the Multi-Skip measurements was sufficiently high to prove that the absence of local wall loss indications (arc-type responses between the skip signals) actually meant that no local wall loss is present.
